Release Notes

MLTG-CN

Version: 1.4.3-00335-9d5e29a
Enhanced from version 1.4.2-00287-d6b0c34

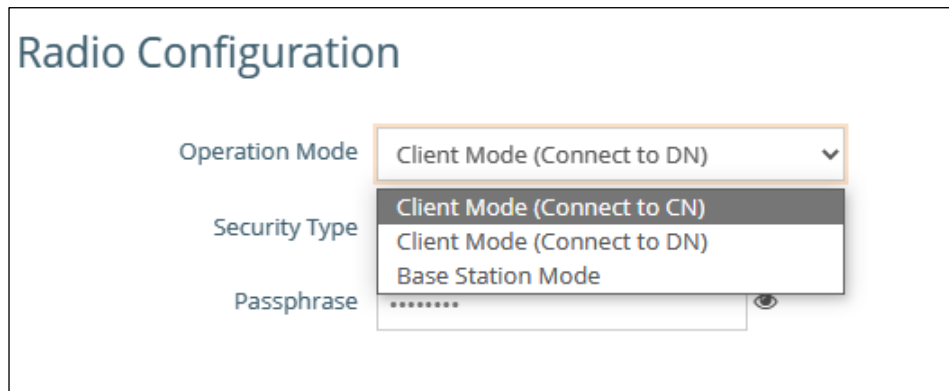
The two types of the client modes are renamed to prevent confusion. Also, it requires to configure the client mode now. When connecting with a DN, please configure it to “Client Mode (Connect to DN)”; when connecting with a base station mode CN, please select “Client Mode (Connect to CN)”.
