Release Note

Edgecore EAP104 Release v12.4.0

Document # EAP104-v12.4.0-980-c4ad2d45

Enhancement from v12.1.0-760-6f3567ae

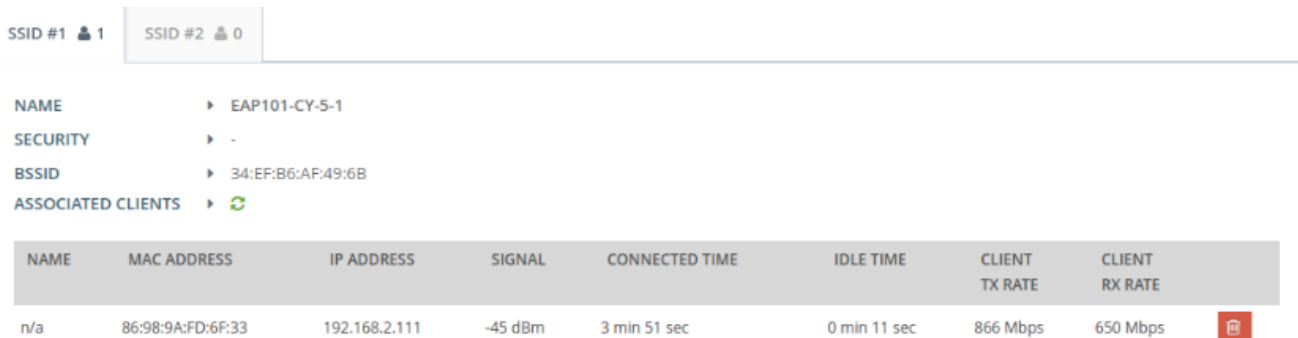
2.22 The duplicate signal value on the wireless status page.

There is the duplicate signal value of the associated clients on the wireless status page. In this version, remove the duplicate signal value on the wireless status page.
