Release Note

Edgecore EAP101 Release v12.4.1

Document # EAP101-v12.4.1-1039-c32b0269

Enhancement from v12.4.0-971-24746b8b

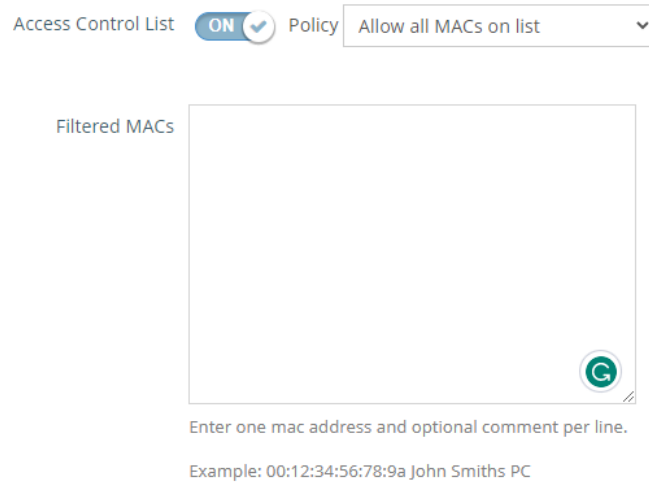
1.1 Access Control List Enhancement

The original number of MACs in the access control list is 128. In this version, the number of MACs is increased to 512 for all policys.

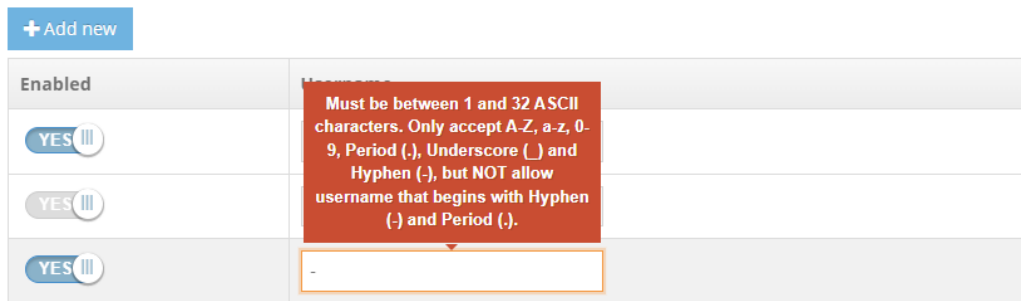
User Accounts

Add the validation for user accounts below.

1. Username - Must be between 1 and 32 ASCII characters. Only accept A-Z, a-z, 0-9, Period (.), Underscore (_) and Hyphen (-), but not allow username that begins with Hyphen (-) and Period (.)
