Release Note

Edgecore EAP104 Release v12.4.9

Document # EAP104-v12.4.9-1299-2b7f49c10

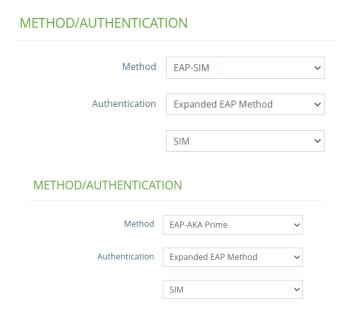
1.1 OpenRoaming Enhancement

Method modification in the OpenRoaming page.

- 1. Support EAP-SIM in NAI Realm List.
- 2. Modify EAP-AKA to EAP-AKA Prime
