Release Note

Edgecore EAP101 Release v11.3.0

Document # EAP101-v11.3.0-968-14b6de43

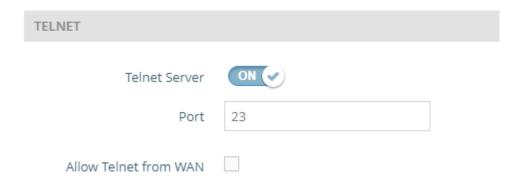
1.1 Telnet

Support telnet in the Services of System page.

- 1. Telnet Server Enables or disables telnet server on the access point.
- 2. Port Sets the TCP port number for the telnet server on the access point.
- 3. Allow SSH from WAN Allows telnet access from the WAN.

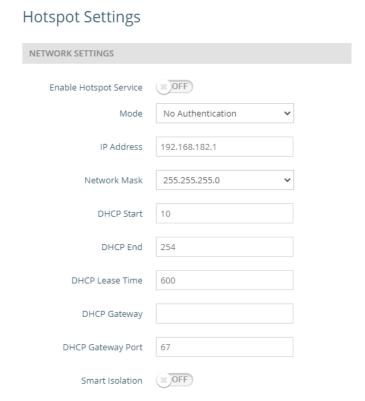
1.4 Hotspot

Support hotspot in the hotspot settings of Network page.

The Hotspot Settings page can configure Internet access to the general public in places such as coffee houses, libraries and hospitals. Specific access rights may also be defined through a RADIUS server.

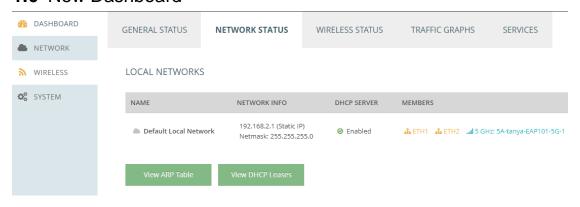
1.6 New Dashboard

Support the new web user interface in the dashboard page.

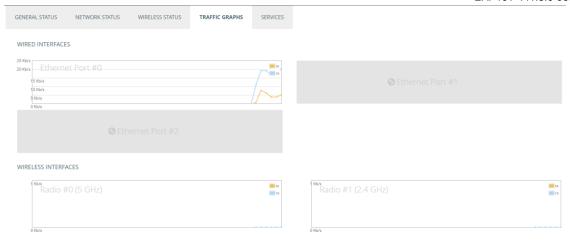
Dashboard – Traffic Graphs

The Traffic Graphs section shows the data rate for the Ethernet ports and wireless interfaces.

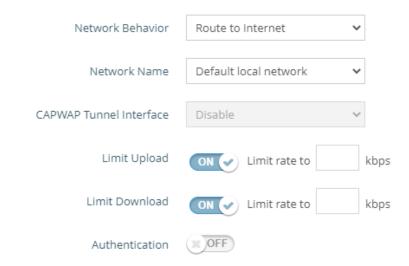
1.7 Limit upload/download

Support limit upload / limit download in the network settings of wireless radio 5/2.4 GHz page.

- 1. Limit Upload Enables rate limiting of traffic from the VAP interface as it is passed to the wired network. You can set a maximum rate in Kbytes per second.
- 2. Limit Download Enables rate limiting of traffic from the wired network as it is passed to the VAP interface. You can set a maximum rate in Kbytes per second.

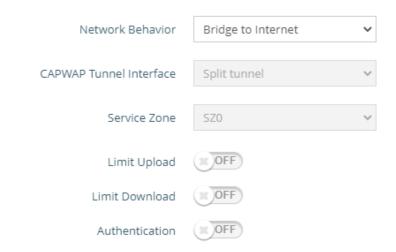
1.8 Split Tunnel

Support split tunnel in the network settings of wireless radio 5/2.4 GHz page.

1 CAPWAP Tunnel Interface – When AP is managed by EWS-Series Controller, CAPWAP tunnel can be set by EWS5203 template.

- 1.1 Disabled Disable tunnel in EAP101.
- 1.2 Complete tunnel Enable complete tunnel feature.
- 1.3 Split tunnel Enable split tunnel feature.

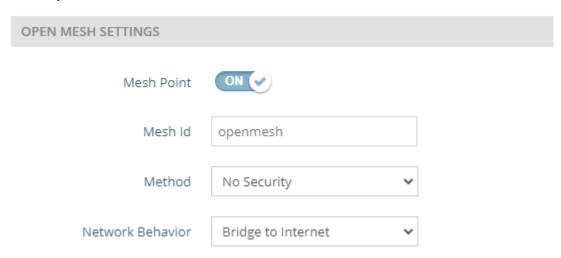
1.9 Open Mesh – Route to Internet

Support network behavior of Open Mesh feature in the Radio 5/2.4 GHz of Wireless page.

- 1 Network behavior select the type of open mesh link.
 - 1.1 Bridge to Internet The mesh link is bridge to the WAN of AP
 - 1.2 Route to Internet The mesh link is bridge to the LAN of AP

This version has been resolved the issue that the network behavior of mesh link in MPP is set to "Route to Internet" and MAP is set to "Bridge to Internet". In some conditions, some error logs are found in the kernel log. It will cause clients can't connect to the Internet.

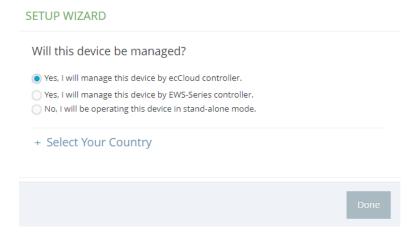
1.11 New setup wizard page

Change the style and layout of setup wizard page.
