## **Release Note**

**Edgecore EAP102 Release v12.5.9**

**Document #** EAP102-v12.5.9-1457-f754fbff3

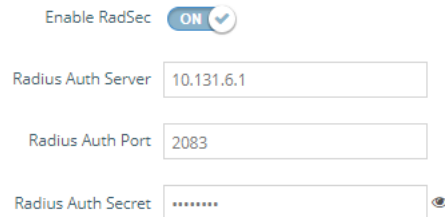
## 1.1 Support RADIUS over TLS (RadSec)

Enable RadSec ☒

Radius Auth Server

Radius Auth Port

Radius Auth Secret

Support for RADIUS over TLS (RadSec) on the wireless SSID.
