## **Release Note**

**Edgecore EAP104 Release v12.5.9**

**Document #** EAP104-v12.5.9-1457-f754fbff3

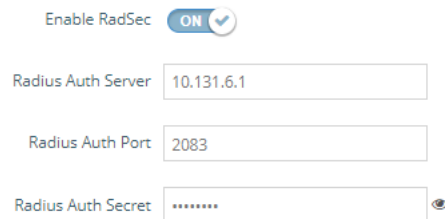
## 1.1 Support RADIUS over TLS (RadSec)

Enable RadSec ☒

Radius Auth Server

Radius Auth Port

Radius Auth Secret

Support for RADIUS over TLS (RadSec) on the wireless SSID.
