Release Note

Edgecore EAP101 Release v12.3.0

Document # EAP101-v12.3.0-862-4973a8d6

Enhancement from v12.2.0-780-fa0042e7

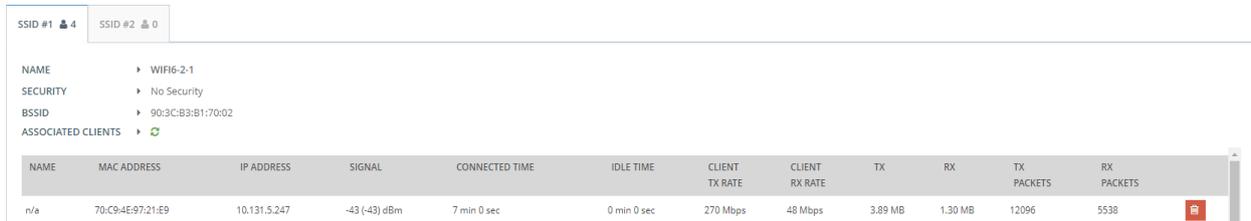
1.2 Disconnect the Associated Client

NAME	MAC ADDRESS	IP ADDRESS	SIGNAL	CONNECTED TIME	IDLE TIME	CLIENT TX RATE	CLIENT RX RATE	TX	RX	TX PACKETS	RX PACKETS
n/a	70:C9:4E:97:21:E9	10.131.5.247	-43 (-43) dBm	7 min 0 sec	0 min 0 sec	270 Mbps	48 Mbps	3.89 MB	1.30 MB	12096	5538

On the Dashboard > Wireless Status page, the associated clients can be disconnected when the red button is clicked.

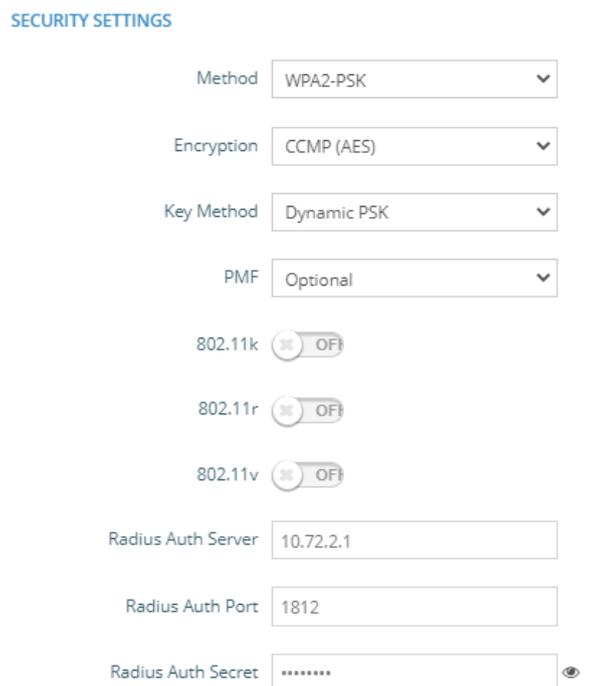
1.3 Dynamic PSK

SECURITY SETTINGS

Method: WPA2-PSK

Encryption: CCMP (AES)

Key Method: Dynamic PSK

Support Dynamic PSK on the Radio 5/2.4 GHz page of Wireless. Set the configuration of radius auth server. The clients can connect to the dynamic PSK SSID using different passwords.

1. Key Method — Select the Dynamic PSK when the security method is WPA2-PSK.
2. Radius Auth Server — Specifies the IP address or host name of the RADIUS Authentication server.
3. Radius Auth port — Specifies the port of the RADIUS Authentication server.

4. Radius Auth Secret — Specifies the shared text string used between the access point and RADIUS server.

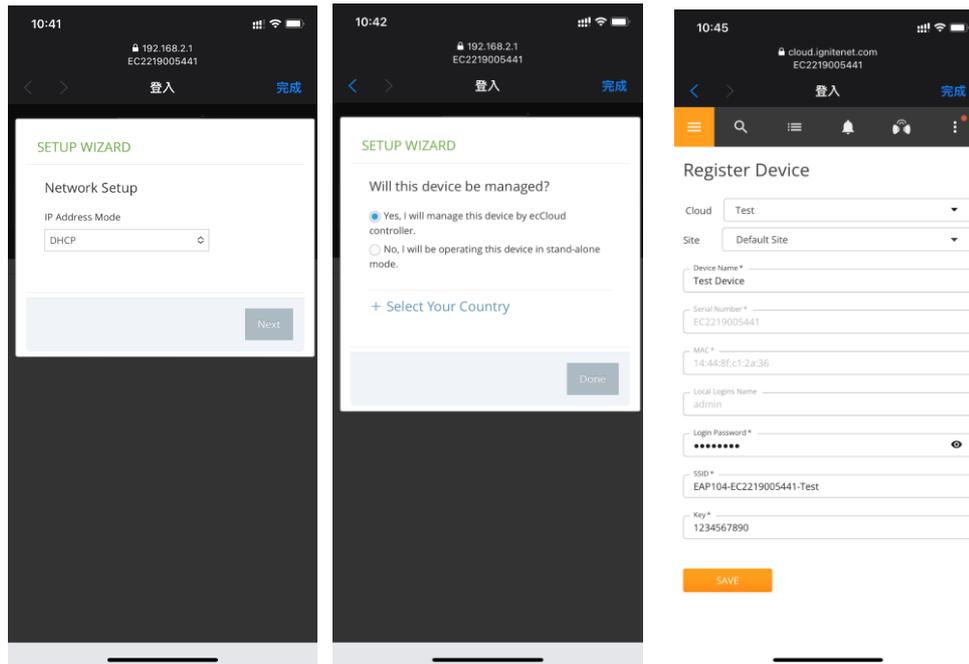
1.9 QR Code Onboarding Enhancement

When the AP is reset to default, use the phone to scan the QR code under the device. The

browser will redirect to setup wizard page. In network setup page, DHCP, static IP, PPPoE can be configured depending on the network environment.

If selecting “stand-alone mode”, the SSID, user name and password can be configured in the setup wizard page.

If selecting “managed by Cloud”, the page will guide to ecCLOUD for registering the AP information including MAC and Serial Number. The SSID, user name and password can be configured in the register device page. QR code onboarding can help speed up the register process of the AP on ecCLOUD without typing the AP information.
