## Release Note

Edgecore EAP102 Release v12.3.0

Document # EAP102-v12.3.0-862-4973a8d6

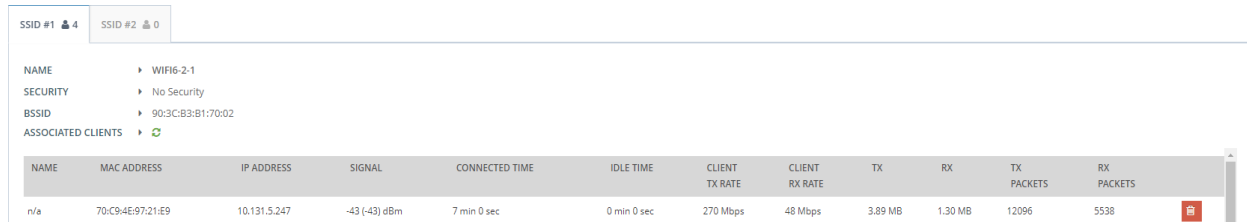
## 1.2 Disconnect the Associated Client

NAME	MAC ADDRESS	IP ADDRESS	SIGNAL	CONNECTED TIME	IDLE TIME	CLIENT TX RATE	CLIENT RX RATE	TX	RX	TX PACKETS	RX PACKETS
n/a	70:C9:4E:97:21:E9	10.131.5.247	-43 (-43) dBm	7 min 0 sec	0 min 0 sec	270 Mbps	48 Mbps	3.89 MB	1.30 MB	12096	5538

On the Dashboard > Wireless Status page, the associated clients can be disconnected when the red button is clicked.

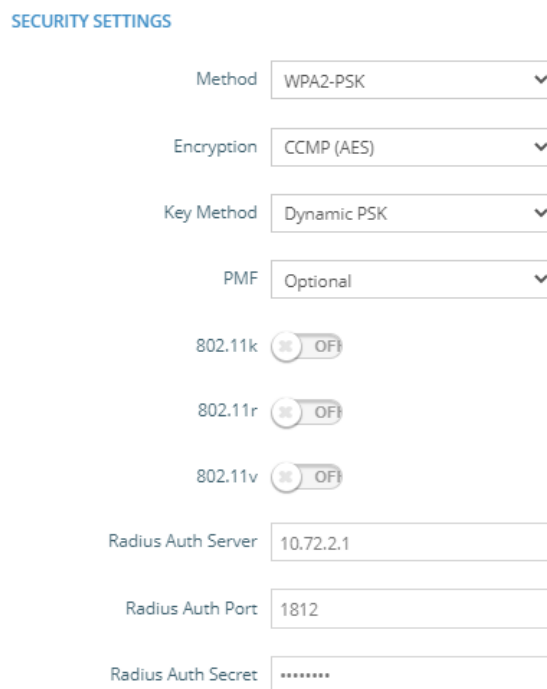
## 1.3 Dynamic PSK

Support Dynamic PSK on the Radio 5/2.4 GHz page of Wireless. Set the configuration of radius auth server. The clients can connect to the dynamic PSK SSID using different passwords.

The following items are displayed on this page:

1. Key Method — Select the Dynamic PSK when the security method is WPA2-PSK.
2. Radius Auth Server — Specifies the IP address or host name of the RADIUS Authentication server.
3. Radius Auth port — Specifies the port of the RADIUS Authentication server.

4. Radius Auth Secret — Specifies the shared text string used between the access point and RADIUS server.

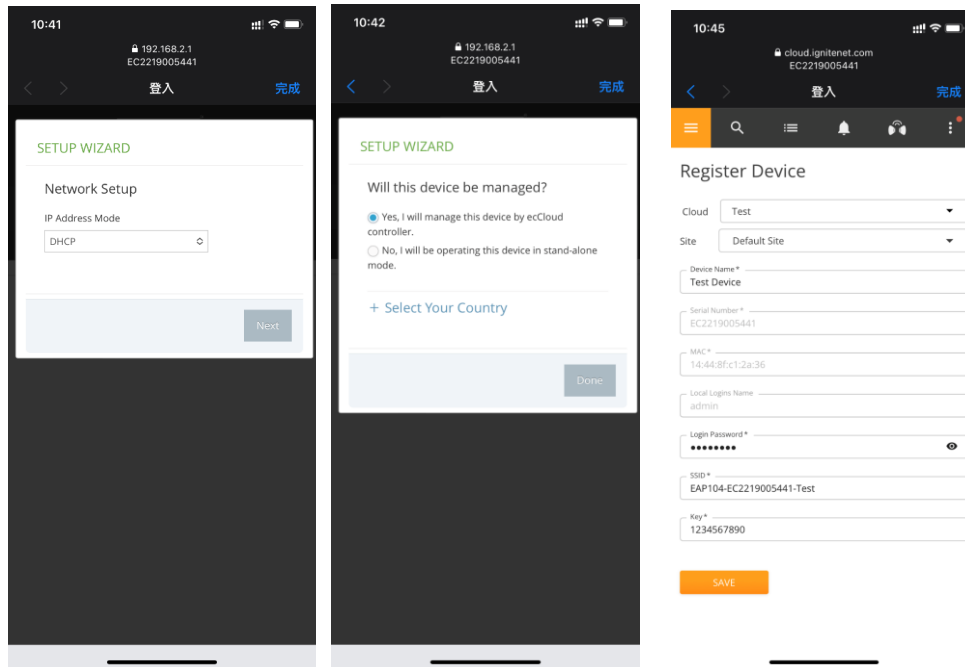
## 1.9 QR Code Onboarding Enhancement

When the AP is reset to default, use the phone to scan the QR code under the device. The

browser will redirect to setup wizard page. In network setup page, DHCP, static IP, PPPoE can be configured depending on the network environment.

If selecting “stand-alone mode”, the SSID, user name and password can be configured in the setup wizard page.

If selecting “managed by Cloud”, the page will guide to ecCLOUD for registering the AP information including MAC and Serial Number. The SSID, user name and password can be configured in the register device page. QR code onboarding can help speed up the register process of the AP on ecCLOUD without typing the AP information.
