Release Note

Edgecore EAP102 Release v12.4.1

Document # EAP102-v12.4.1-1039-c32b0269

Enhancement from v12.4.0-971-24746b8b

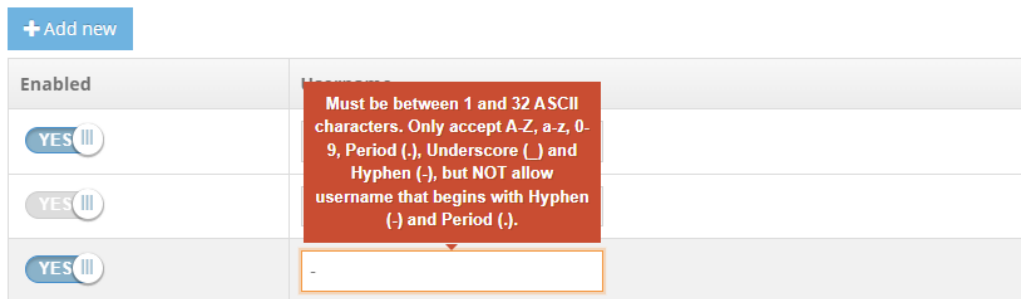
User Accounts

Add the validation for user accounts below.

1. Username - Must be between 1 and 32 ASCII characters. Only accept A-Z, a-z, 0-9, Period (.), Underscore (_) and Hyphen (-), but not allow username that begins with Hyphen (-) and Period (.)
