Release Note

Edgecore OAP101 Release v12.5.7 Document # OAP101-v12.5.7-1455-c379f8977

Enhancement from v12.4.3-1070-a14c95a37

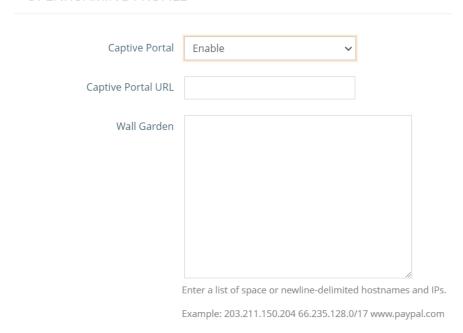
OPENROAMING PROFILE

- 1. Captive Portal: Enabled or disabled captive portal.
- 2. Captive Portal URL: Enter the Valid captive portal URL, http or https.
- 3. Walled Garden: Enter a list of space or newline-delimited hostnames and IPs.

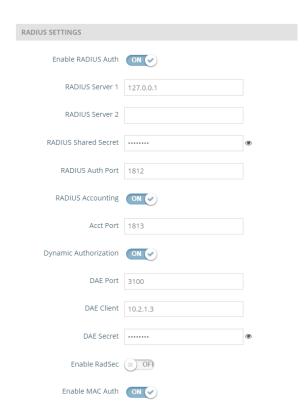
Hotspot Settings

Hotspot Enhancement

- 1. Support RADIUS MAC auth. When Radius MAC authentication is enabled, if the associated client is in the RADIUS MAC list, the client can connect to the Internet directly; otherwise, the hotspot captive portal will be displayed.
- 2. Support Dynamic Authorization. When Dynamic Authorization is enabled, the AP can support dynamic authorization feature by DAE port, DAE client and DAE secret.
- 3. Support for RADIUS accounting disabled. When Radius accounting is disabled, the AP turns off the RADIUS accounting feature.
